# Investigation of the UH-60 Main Rotor Spindle Assembly Retaining Rods P/N 70102-08102/-103

ARL-TR-1585

January 1998

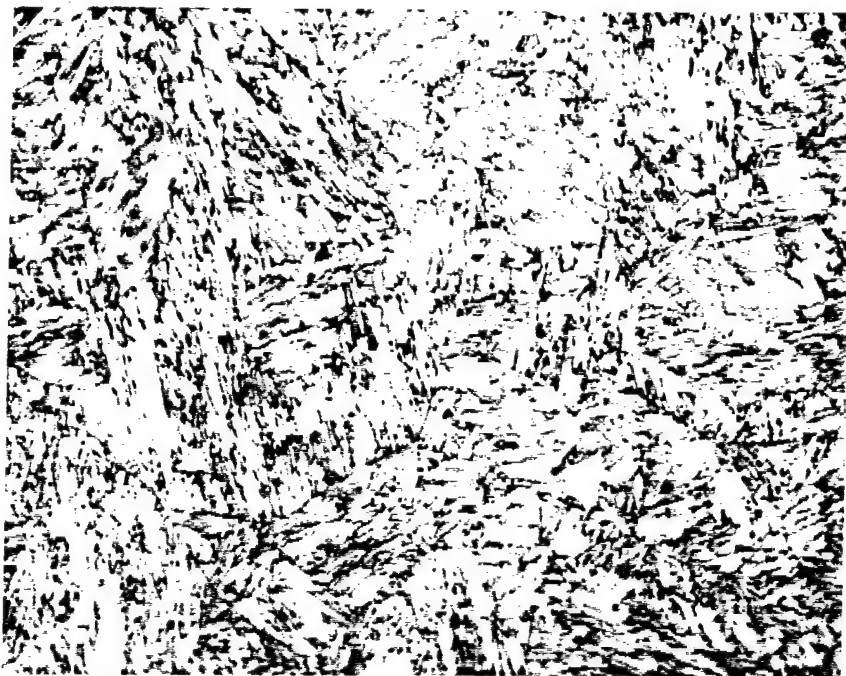
**Figure 41. Structure of PUR Sample -174 in the Longitudinal Direction. Vilella's Reagent (Mag. 1kx).**

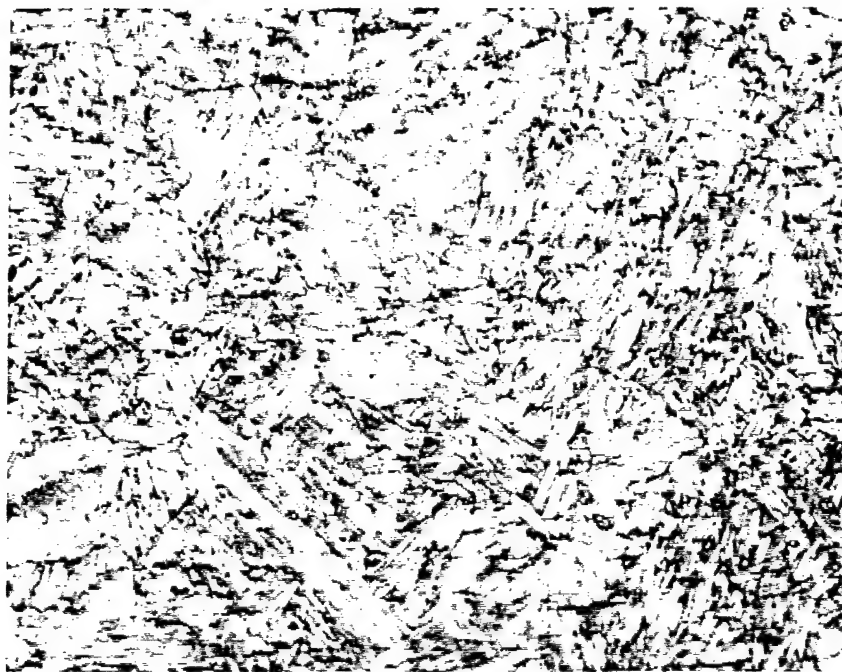
**Figure 45. Structure of SIK Sample -00973 in the Longitudinal Direction. Vilella's Reagent (Mag. 1kx).**

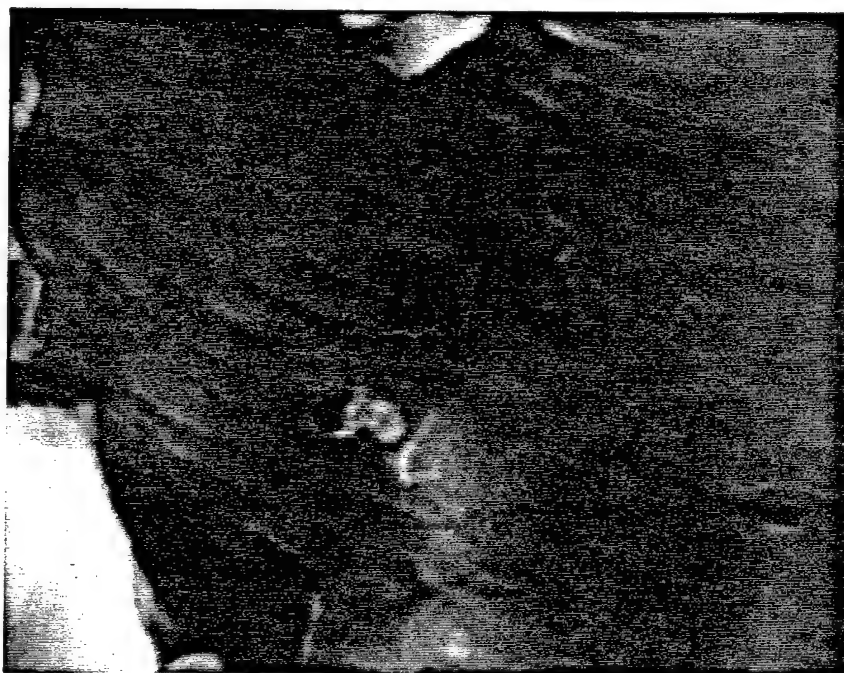
-2 and -3, respectively. As shown in Figure 56, the -00938 sample contained seven origins. One of the origins (right side of schematic) was on a different fracture plane than the remaining six origins. Fatigue progressed approximately 40% of the fracture surface as indicated by the transgranular fracture morphology, until final fast fracture occurred. This fast fracture was characterized by shear lips containing ductile dimples, indicative of tensile overload. Figures 62–70 are SEM micrographs that represent the fracture morphology of each of the regions illustrated in Figure 56. Figures 62 and 63 represent the origins, while Figure 64 shows the transgranular morphology characteristic of the fatigue zone. Figure 65 represents the fatigue and ductile interface, while Figure 66 represents typical striations on the fracture surface at low magnification. Figures 67–70 also represent the fatigue striations contained within the fracture surface at higher magnification.

**Figure 67. Striations Noted on the Surface of SIK Rod -00938 (Mag. 25kx).**

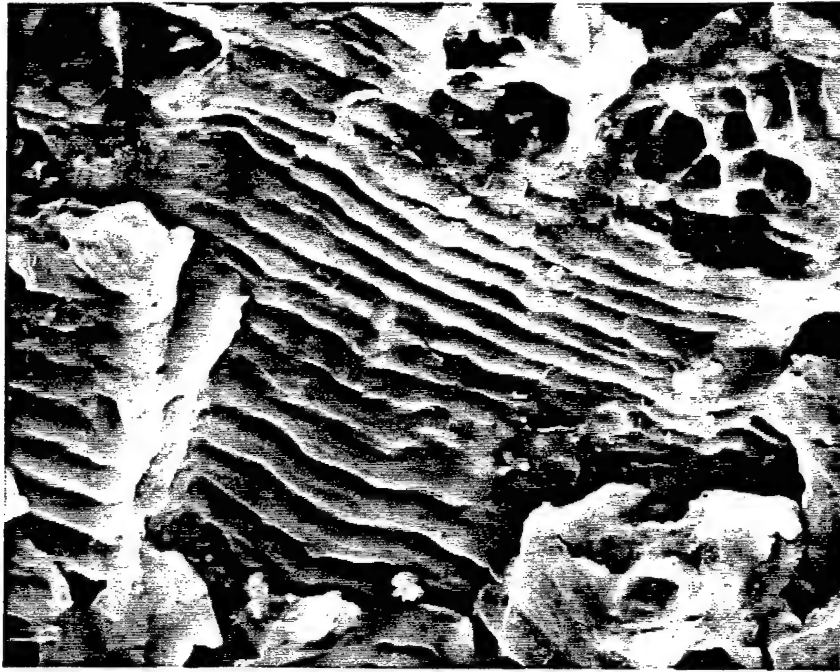
**Figure 70. Striations Noted on the Surface of SIK Rod -00938 (Mag. 5kx).**

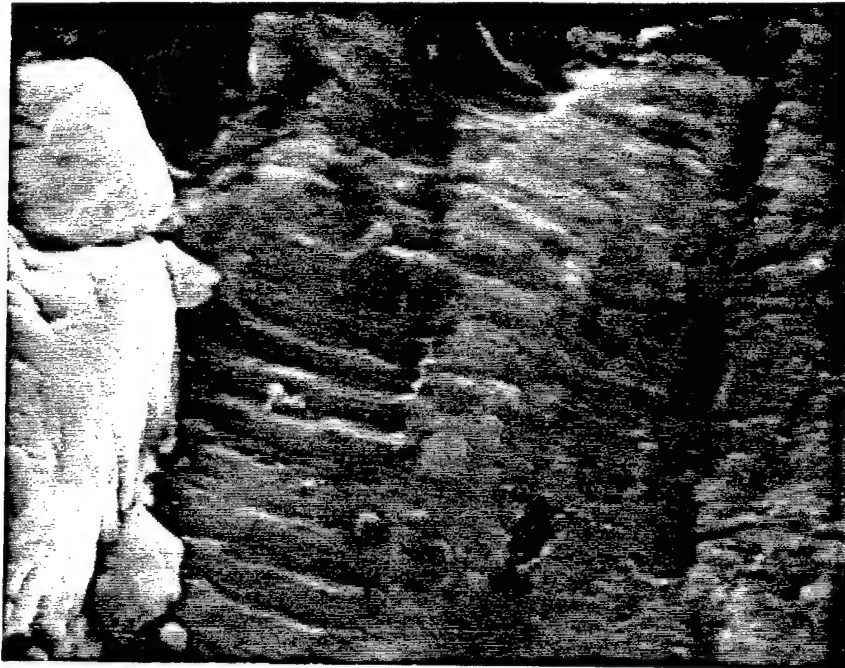
Figure 92 shows a low-magnification SEM micrograph of a typical origin noted on the PUR -177 fracture surface (Figure 59), while Figure 93 depicts the typical transgranular cyclic fatigue morphology. Figure 92 shows a morphology consisting of tearing with striations. Figure 94 shows a morphology consisting of tearing and a transgranular mode, as well as slight ductility. Figure 95 contains striations mixed with ductility, as well as cyclic overload, while Figure 96 shows ductile dimples with evidence of incremental loading. Figure 97 shows these ductile dimples at higher magnification. Figures 98–102 represent typical fatigue striation differences noted on the fracture surface of the PUR specimens.

**Figure 98. Striations Noted on the Fracture Surface of PUR Rod -177 (Mag. 10kx).**
